INSPECTION AND REPLACEMENT OF NOSE GEAR DRAG LINKS

Lancair IV, IV-P, IV-PT, and Legacy

SB078-0722

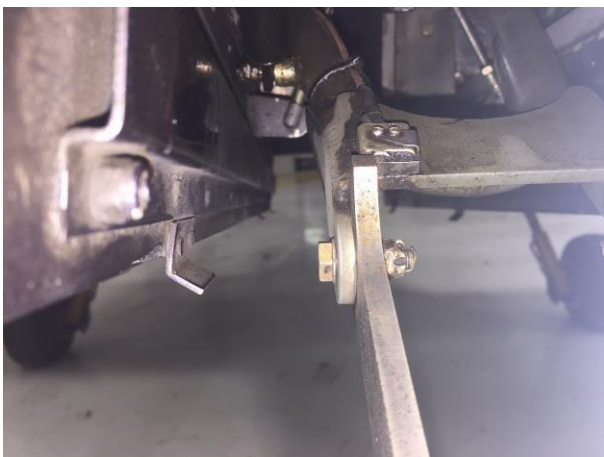
Figure 1
Original Design Lower Drag Links

- 6.1 Determine if the aircraft is equipped with the original or improved design lower drag links. The original upper and lower drag links were joined by two AN4 pivot bolts with cotter-pinned castle nuts that allow them to pivot on the bolts during gear retraction (Figure 1). The improved lower drag links added a bronze bushing to each of the lower drag links at the center pivot point (Figure 2). Both styles of Lower Drag Links are **superseded** by the new components detailed in this Service Bulletin (PN 433-1001, Lower Drag Link LH and PN 433-1002, Lower Drag Link RH).

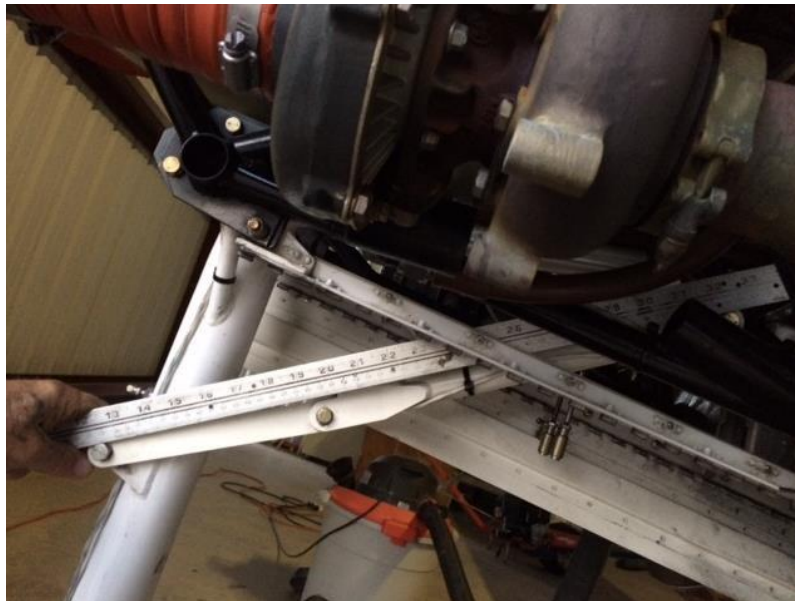
Figure 3

- 6.2.1** Aircraft equipped with the original steel-on-steel pivots (without the bronze bushings) will have a bolt with a castle nut secured with a cotter pin. Aircraft equipped with the improved pivots will have a tension bolts and locking nut.
- 6.2.1.1** Using a straightedge, check that the drag links are over-center shown in Figure 3. There is no “over-center distance” specified, but a range from $\frac{1}{4}$ ” to $\frac{1}{2}$ ” as measured from the centerline of the pivot bolt joining the upper and lower links is ideal.

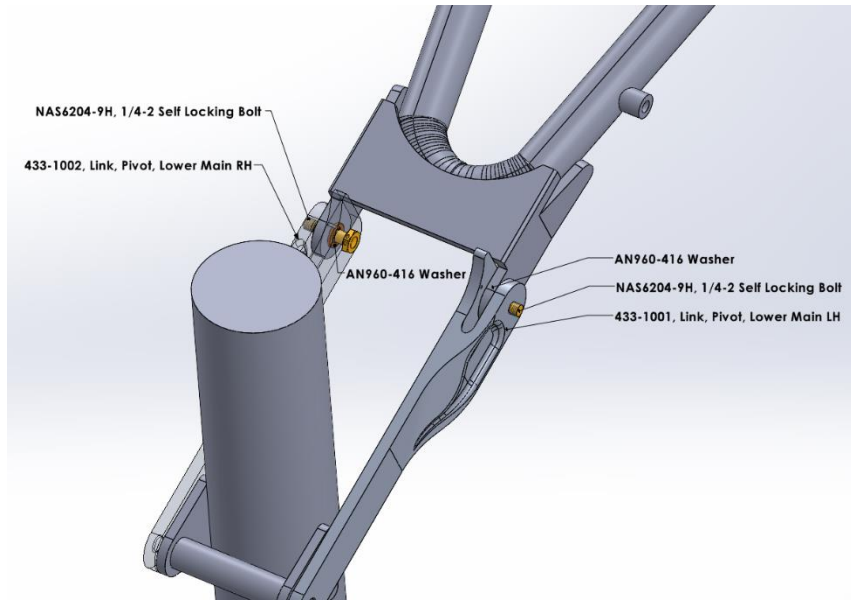
Figure 4

- 7.2** Procedure (See Figure 2 and 4):
- 7.2.1** Lubricate lightly and install the new 433-1001 Lower Drag Link LH and 433-1002 Lower Drag Link RH.
- 7.2.2** Install the new lower links to the over center link using NEW NAS6204-9H Self Locking Bolts (head on inside of the assembly, threads going outboard) and AN960-416 Washers.

- 7.2.3** Before attaching the 433-1001 & 433-1002 Lower Drag Links to the nose strut, torque the above bolts to 90-100 in./lb. and ensure each of the two lower links will pivot on the upper link through the full range of movement required during gear retraction.

If the full range of motion is achieved, safety wire both NAS6201-9H Self Locking Bolts to the corresponding Lower Drag Link. A small hole for safety wire can be found on the curvature of the stop.

SB074-0111 applies to both over center link tab configurations shown in Fig. 4, SB074-0111 also addresses the installation of a Hydraulic actuator end with a spherical bearing. For further details on the inspection please refer to SB074-0111.
